8.1. Introduction

## 8.2. Vacuum Vessel Design

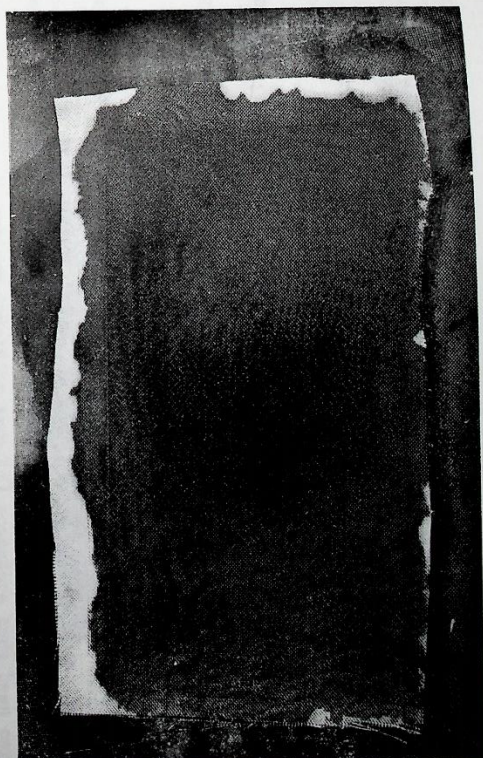
Fig. 8.7(iv) Typical repair profile

(a) PLAN VIEW OF PORTION OF VESSEL CUT FOR REPAIR

NOT TO SCALE

These areas were easily defined by a whitened appearance (Fig. 8.7(i)) and Fig. 8.7(ii)) and the complete removal of the faulty area was necessary. The faulty fabrics were removed singly using a sharp knife, or a wood chisel and a spatula. A half inch step was introduced every two layers of fabric (Fig. 8.7(iii)) and Fig. 8.7(iv)) to achieve the required mechanical strength in the finished repair.
